Manhole Inspection Summary

Manhole # S11GG2010MH

Insp Date: **7/7/06 3:39 PM**

Location Address: **2320 BRIGHT LEAF WAY**

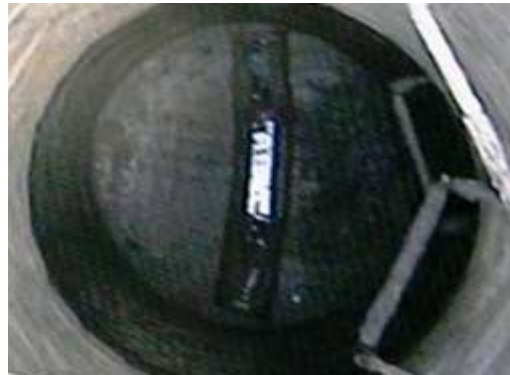
Top View

☒ **Debris** (not Condition related)

☒ **Corroded**

Corroded steps. Bench debris.

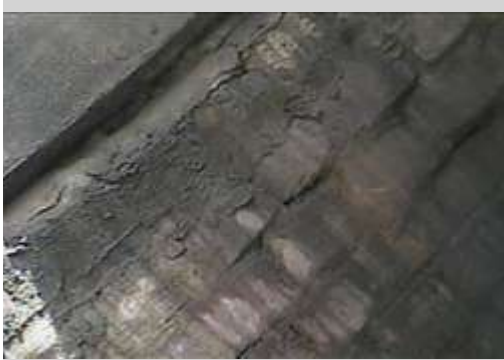
Defect

☒ **Leaks**

Infiltration: ☐ None ☒ **Joint** ☐ Cracks ☐ Mortar ☐ Roots ☐ Wall

Frame leaks. Adjustment infiltration.

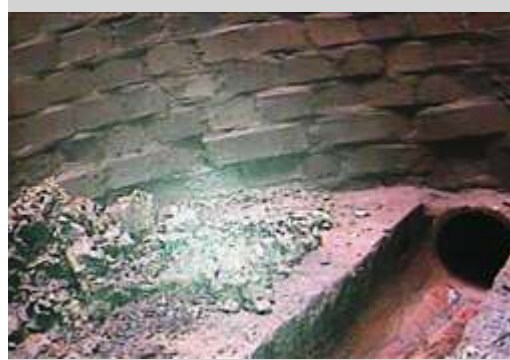
Defect

Condition: ☐ Sound ☐ Cracked ☐ Root Intrusion ☐ Loose Brick ☒ **Deteriorated**

Infiltration: ☐ None ☐ Joint ☐ Cracks ☒ **Mortar** ☐ Roots ☒ **Wall**

Barrel deterioration and infiltration.

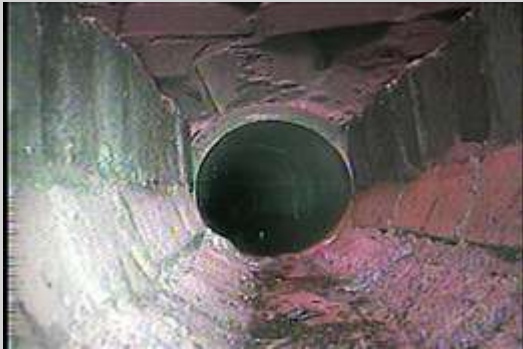
8 in. Circular Gravity Sewer Pipe Out @ 12 O'Clock

Condition: ☐ Sound ☐ Cracked ☐ Root Intrusion ☒ **Deteriorated** ☐ Leaks ☐ Debris

Channel deterioration.
